BOYERTOWN RESERVOIR DAM

NDI-PA 00707
PA DER 6-344

PHASE I INSPECTION REPORT NATIONAL DAM INSPECTION PROGRAM

80-7
AUGUST 1979

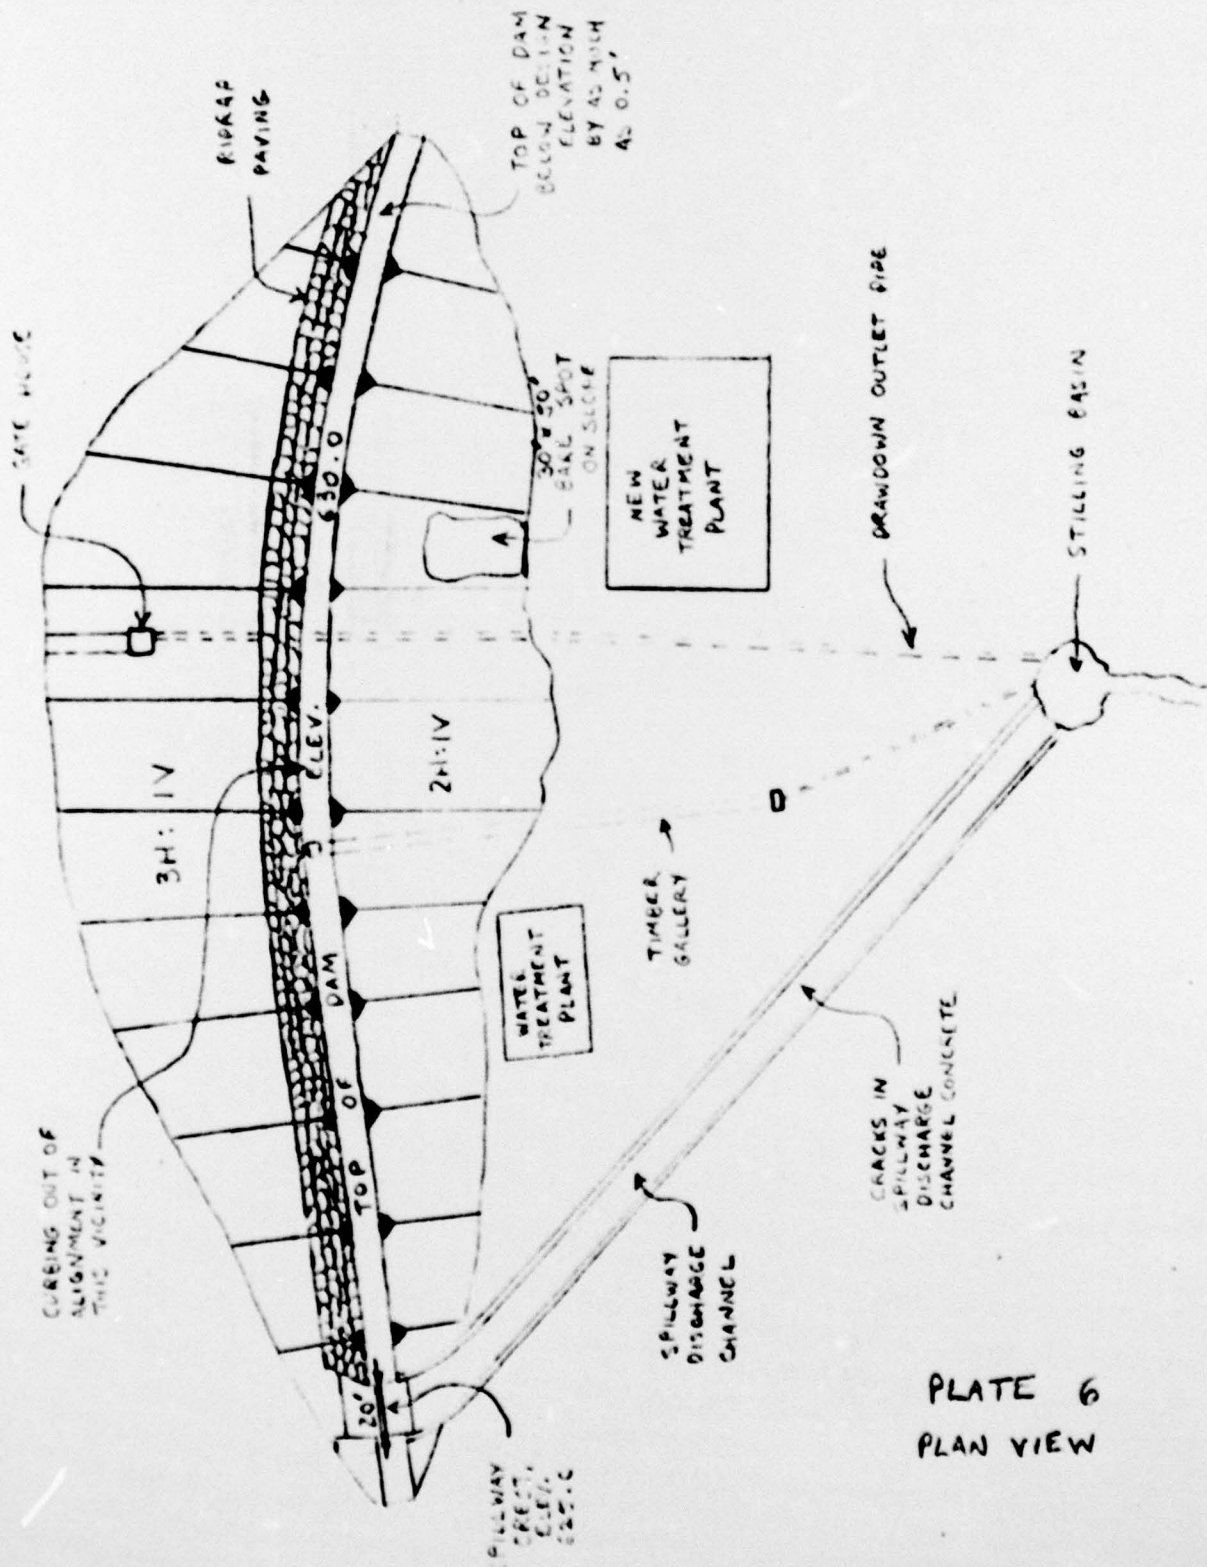
PLATE 6
PLAN VIEW

b. Dam. A survey revealed that the top of dam has settled several inches below design elevation along most of its length. A maximum depression of about six inches was observed from approximately 80 to 140 feet to the left of the spillway.

The downstream slope of the embankment supports a good cover consisting mainly of crown vetch. A bare spot about 50 feet by 100 feet was observed near the downstream toe approximately 200 feet from the left abutment. This bare spot was apparently related to the construction work on the new water treatment plant.

4. The cracks in the spillway discharge channel should be repaired to prevent scour beneath the discharge channel and further deterioration of the concrete.
